## Portrait SPF

## Mobile PV-Lab since 2016

## Which measurements could be done?

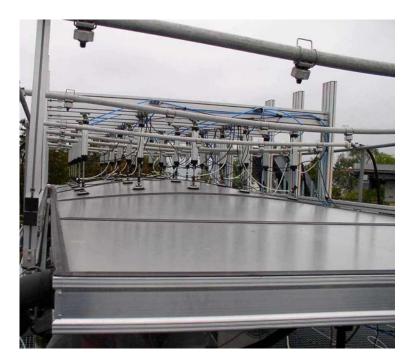
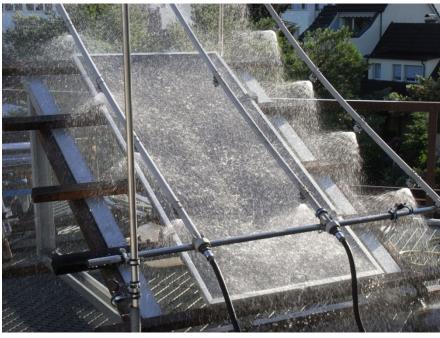
## **Example: Collector Testing**

e.g. Solar Thermal / PV Glass

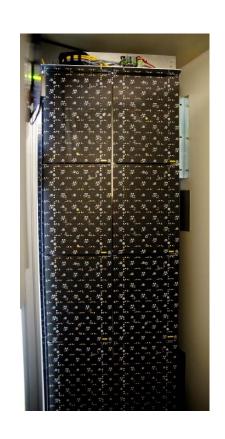
### settings

- air conditioning STC 25 C°
- long-Pulse LED Flasher
  - polycristalline reference cell
  - class triple A: spectrum (A+), stability (A+++), homogeneity (A), according to IEC 60904-9 Ed.2
  - Irratiation 200 1200 W/m²
- Power accuracy: +/- 3%, repeatability: < 0.5%
- 2 MBJ NIR-CCD (cooled) cameras
  - resolution 300 µm/Pixel (20 MPixel per module)
- MBJ IR camera 160 x 120 pixel
- 24" monitor

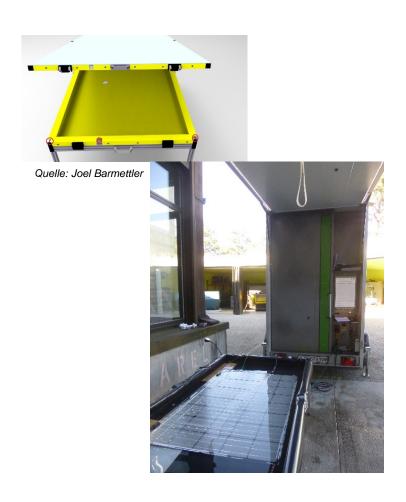
#### High-voltage-test

- Grounding consistency (MST 13)
- Leakage resistance (MST 16 based on IEC 61730-2)
- Wet leakage test: leakage current under wet conditions (MST 17)
